2023 Maintenance Inspection Form

Date/Time	03-14-2023
Job Number	
Property Name	Roseview
Inspected By	
Photo of Community

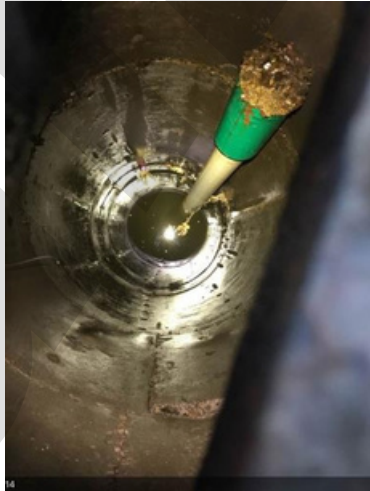
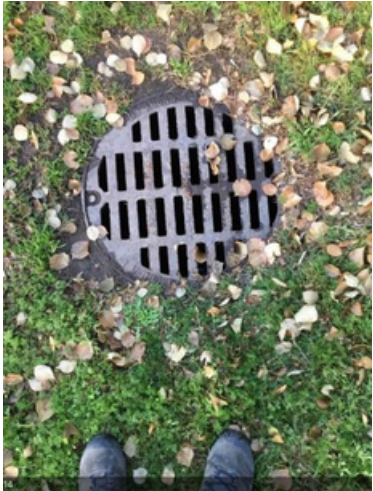
Structure Number	14
Structure Type	Drywell
Structure Size	24"
Depth to Debris	N/A
Screen Condition	Fair
SP/ST Condition	Good
Vent Cap Condition	Unknown
Maintenance Needed	Hydrovac cleaning needed.
Notes for Maintenance	Moderate amount of dirty standing water and landscape debris.
Repairs Needed	None
Drywell Photos

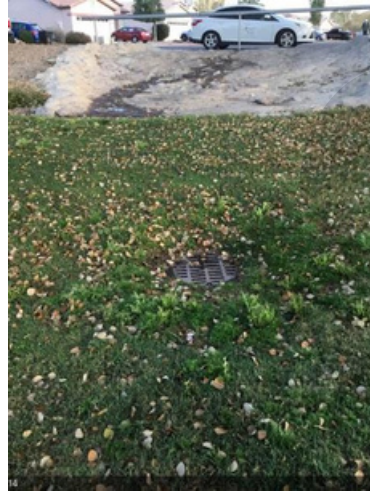
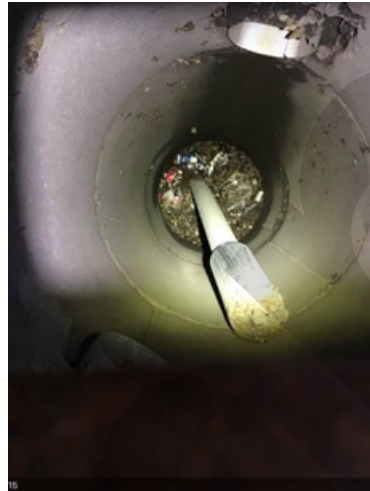
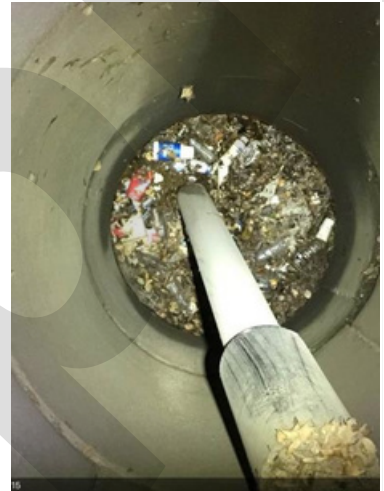
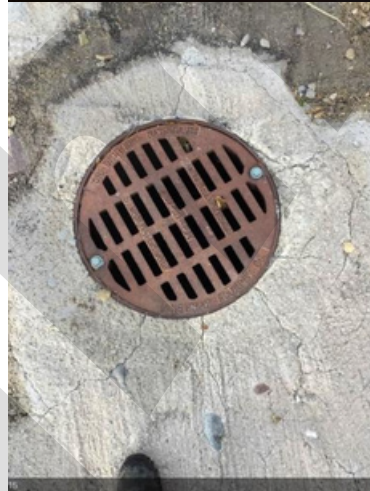
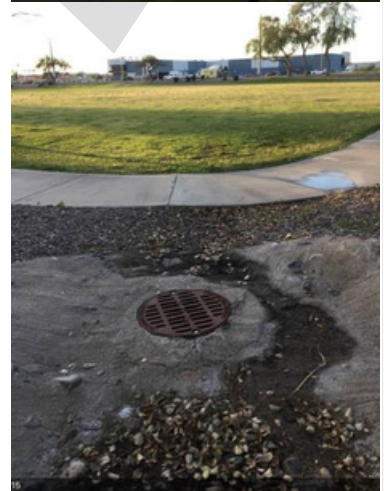
Structure Number	15
Structure Type	Drywell
Structure Size	24"
Depth to Debris	16'7"
Screen Condition	Fair
SP/ST Condition	Leaning standpipe needs repair.
Vent Cap Condition	Unknown
Maintenance Needed	Hydrovac cleaning needed.
Notes for Maintenance	Moderate amount of landscape debris buildup and trash.
Repairs Needed	Replace bracket.

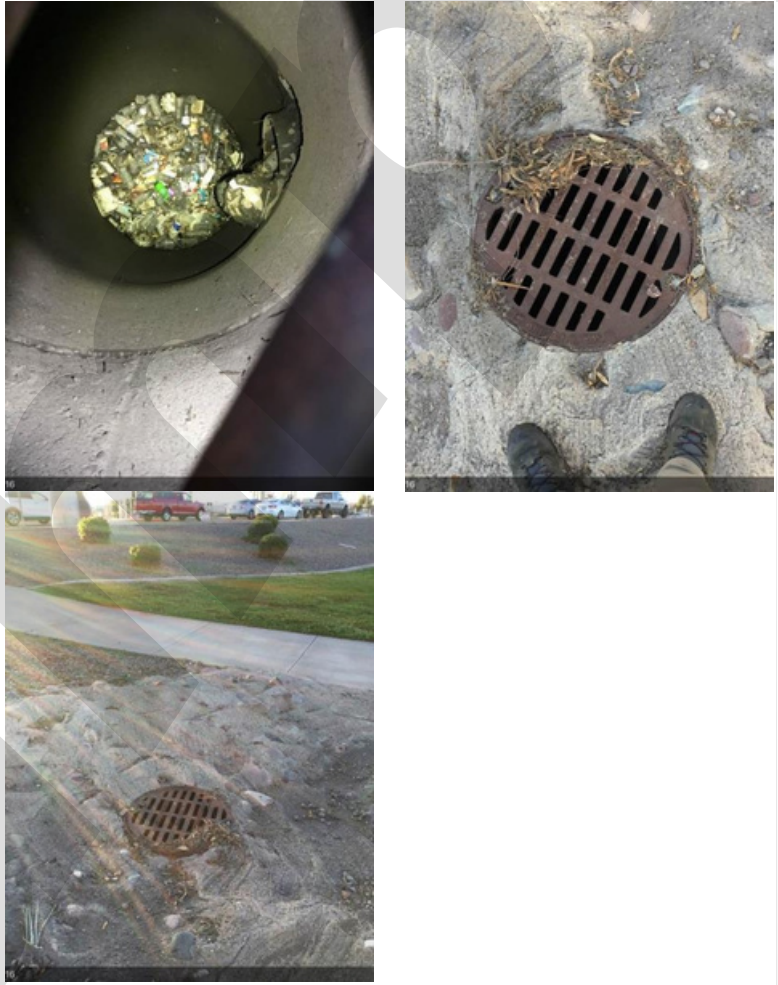
Structure Number	16
Structure Type	Drywell
Structure Size	24"
Depth to Debris	11'4"
Screen Condition	Unknown
SP/ST Condition	Unknown
Vent Cap Condition	Unknown
Maintenance Needed	Hydrovac cleaning needed.

Notes for Maintenance	Significant amount of trash buildup and landscape debris.
Repairs Needed	None
Drywell Photos

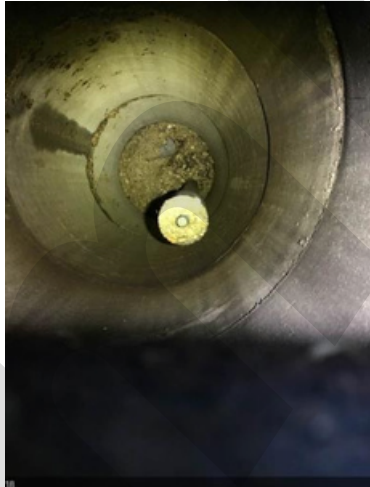
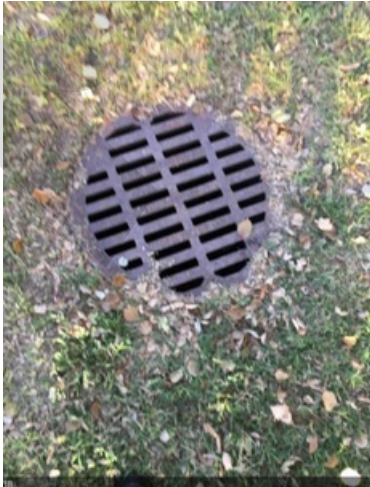
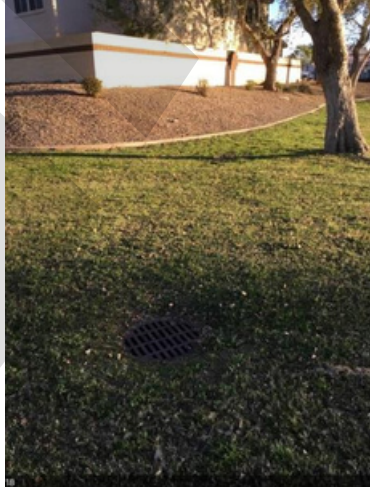
Structure Number	18
Structure Type	Drywell
Structure Size	24"
Depth to Debris	18'6"
Screen Condition	Fair

SP/ST Condition	Good
Vent Cap Condition	Unknown
Maintenance Needed	Hydrovac cleaning needed.
Notes for Maintenance	Moderate amount of landscape debris buildup and dirt
Repairs Needed	None
Drywell Photos

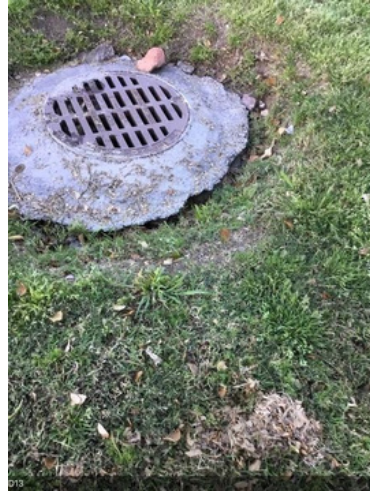
Structure Number	13
Structure Type	Drywell
Structure Size	24"

Depth to Debris	15'8"
Screen Condition	Rusted. Replace with PureWell, non-rusting screen.
SP/ST Condition	Good
Vent Cap Condition	Good
Maintenance Needed	Hydrovac cleaning needed.
Notes for Maintenance	Moderate amount of landscape debris buildup and trash.
Repairs Needed	Replace debris screen., Repair concrete collar.
Drywell Photos

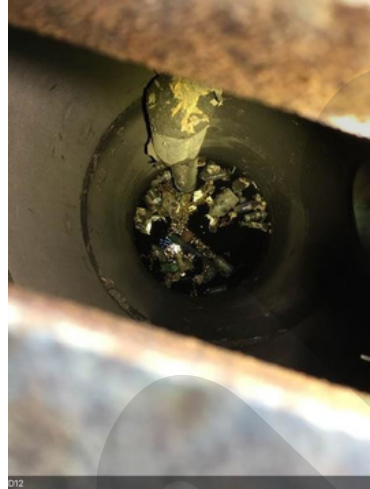
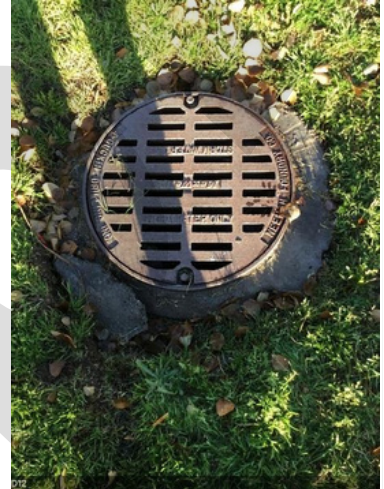
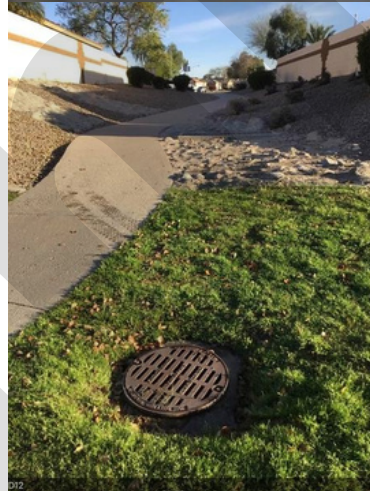
Structure Number	12
Structure Type	Drywell
Structure Size	24"
Depth to Debris	N/A
Screen Condition	Rusted. Replace with PureWell, non-rusting screen.
SP/ST Condition	Good
Vent Cap Condition	Unknown
Maintenance Needed	Hydrovac cleaning needed.
Notes for Maintenance	Moderate amount of trash and dirty standing water.
Repairs Needed	Replace debris screen., Repair concrete collar.

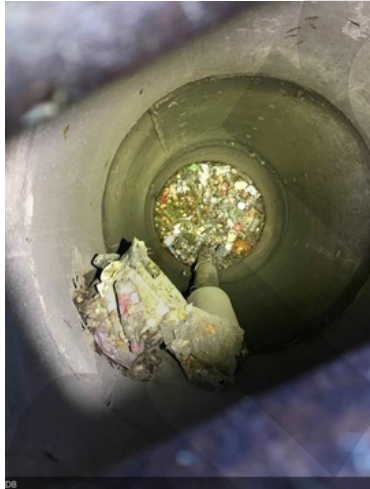
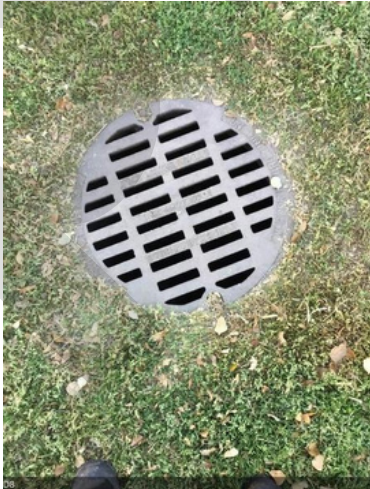
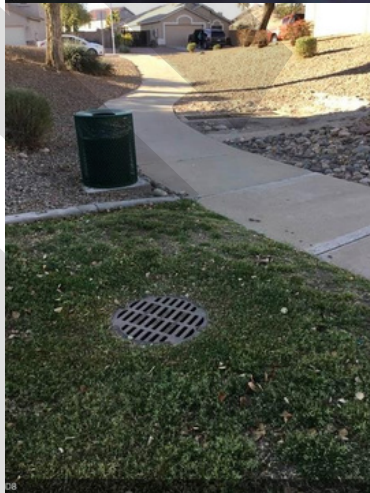
Structure Number	8
Structure Type	Drywell
Structure Size	24"
Depth to Debris	15'10"
Screen Condition	Unknown
SP/ST Condition	Good
Vent Cap Condition	Unknown
Maintenance Needed	Hydrovac cleaning needed.

Notes for Maintenance	Significant amount of landscape debris buildup and trash.
Repairs Needed	None
Drywell Photos

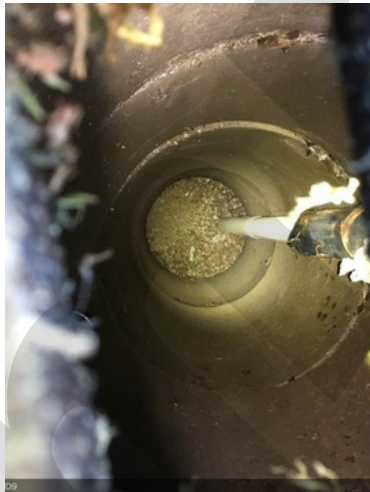
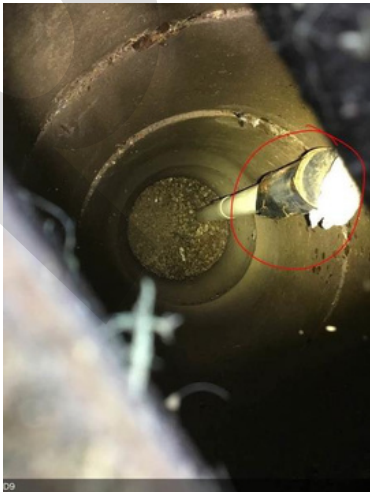
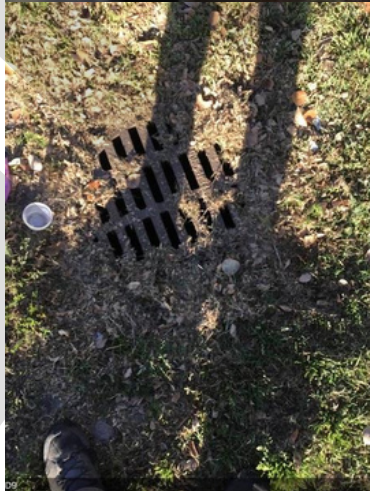
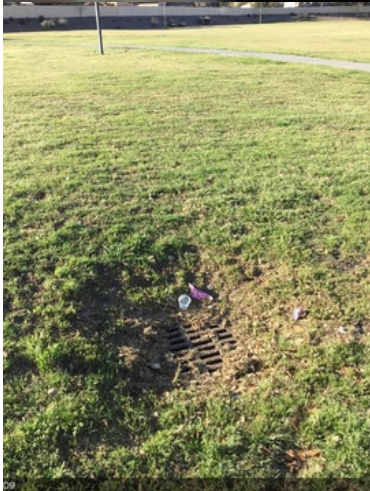
Structure Number	9
Structure Type	Drywell
Structure Size	24"
Depth to Debris	17'
Screen Condition	Damaged. Replace with PureWell, pvc, non-rusting debris screen.

SP/ST Condition	Good
Vent Cap Condition	Unknown
Maintenance Needed	No work needed.
Repairs Needed	Replace debris screen.
Drywell Photos

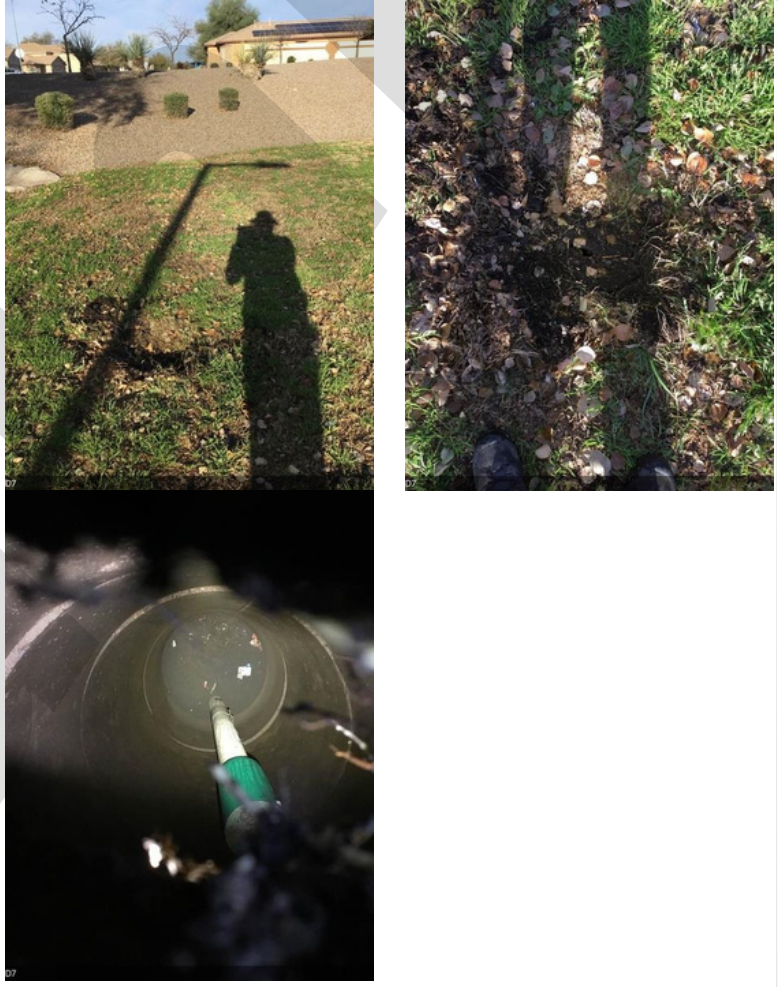
Structure Number	7
Structure Type	Drywell
Structure Size	24"
Depth to Debris	17'

Screen Condition	Fair
SP/ST Condition	Good
Vent Cap Condition	Good
Maintenance Needed	Hydrovac cleaning needed.
Notes for Maintenance	Moderate amount of compacted dirt buildup
Repairs Needed	None
Drywell Photos

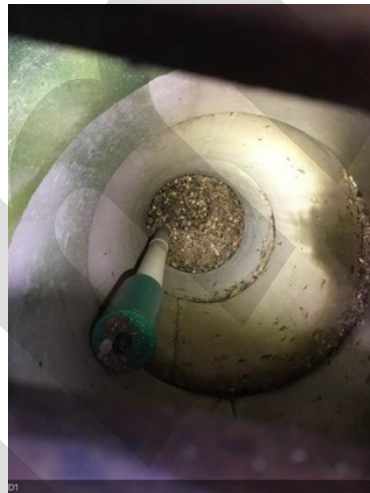
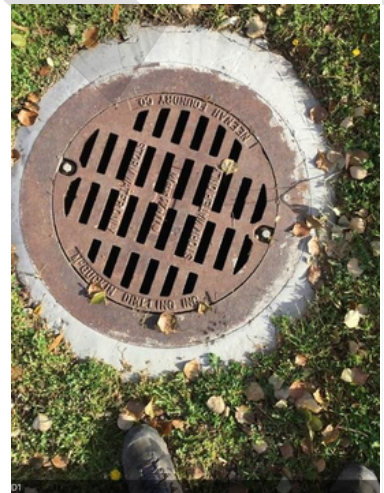
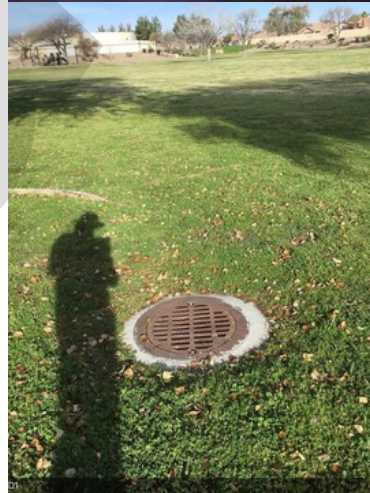
Structure Number	1
Structure Type	Drywell

Structure Size	24"
Depth to Debris	17'9"
Screen Condition	Fair
SP/ST Condition	Good
Vent Cap Condition	Good
Maintenance Needed	Hydrovac cleaning needed.
Notes for Maintenance	Moderate amount of landscape debris buildup
Repairs Needed	None

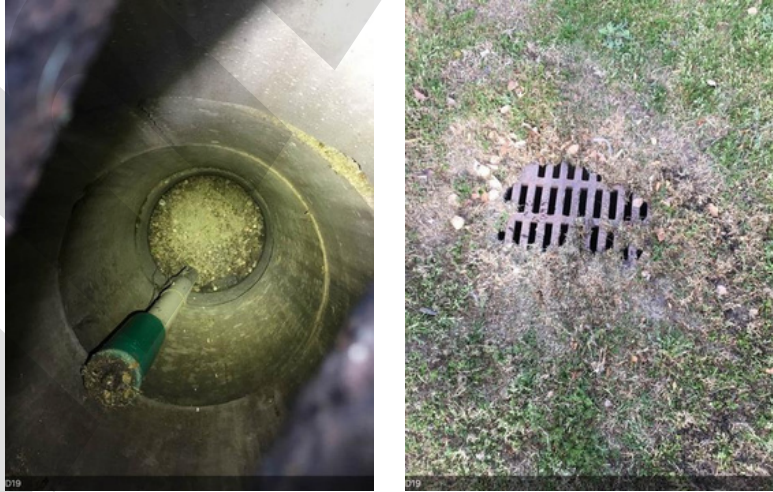
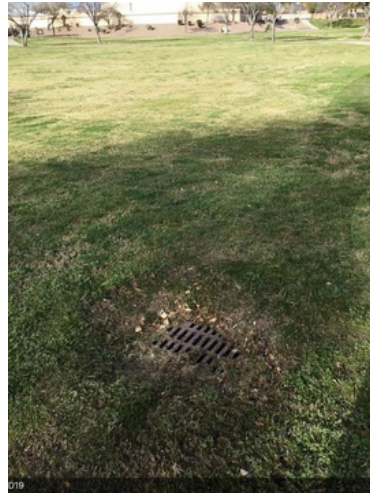
Structure Number	19
Structure Type	Drywell
Structure Size	24"
Depth to Debris	14'11"
Screen Condition	Fair
SP/ST Condition	Good
Vent Cap Condition	Good
Maintenance Needed	Hydrovac cleaning needed.
Notes for Maintenance	Moderate amount of landscape debris buildup and dirt
Repairs Needed	None
Drywell Photos

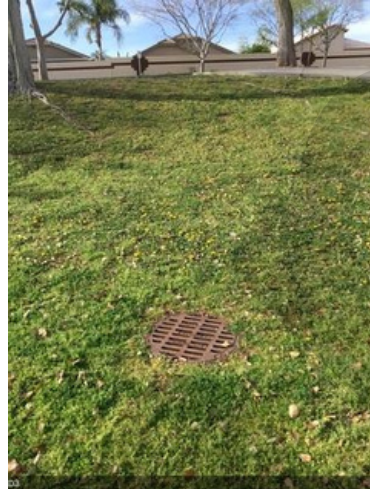
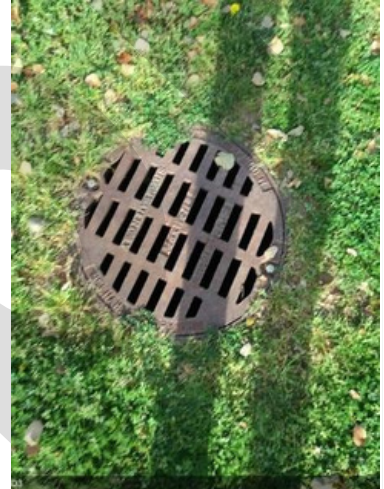
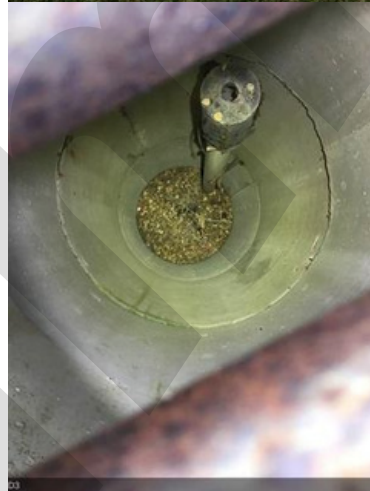
Structure Number	3
Structure Type	Drywell
Structure Size	24"
Depth to Debris	18'1"
Screen Condition	Damaged. Replace with PureWell, pvc, non-rusting debris screen.
SP/ST Condition	Good
Vent Cap Condition	Vent cap is missing
Maintenance Needed	No work needed.
Repairs Needed	Replace debris screen., Replace bracket.

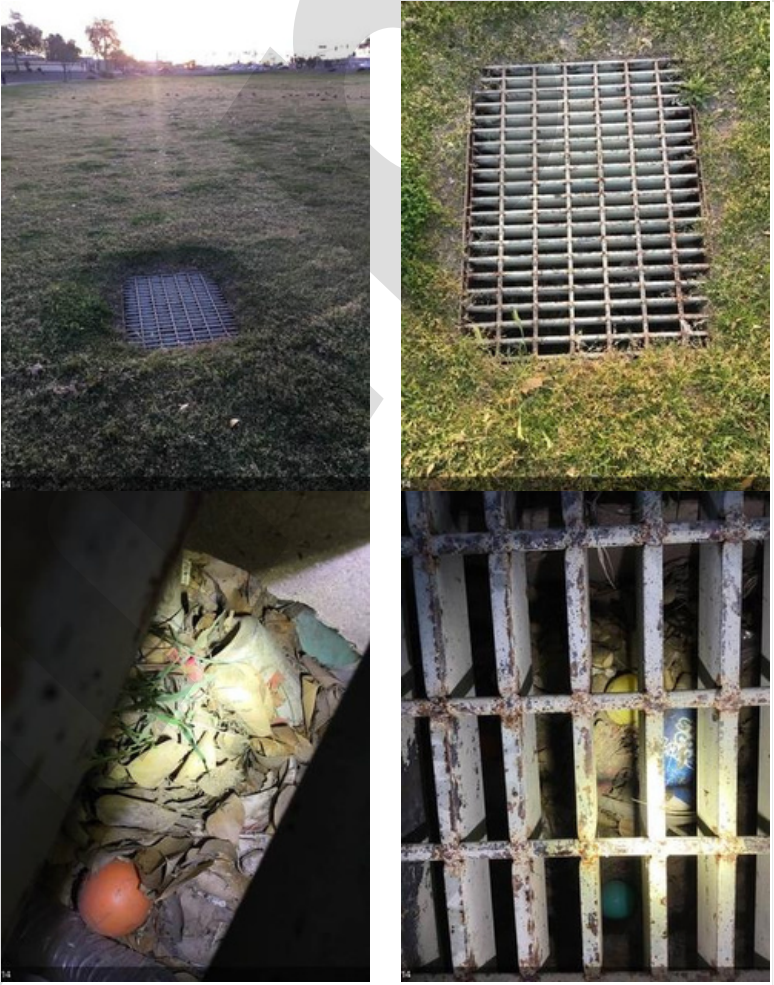
Structure Number	14
Structure Type	Catch Basin
Structure Size	30"x40"
Depth to Debris	11"
Maintenance Needed	Hydrovac cleaning is needed.

Maintenance Notes	Moderate amount of landscape debris buildup and trash.
Repairs Needed	None
Photos

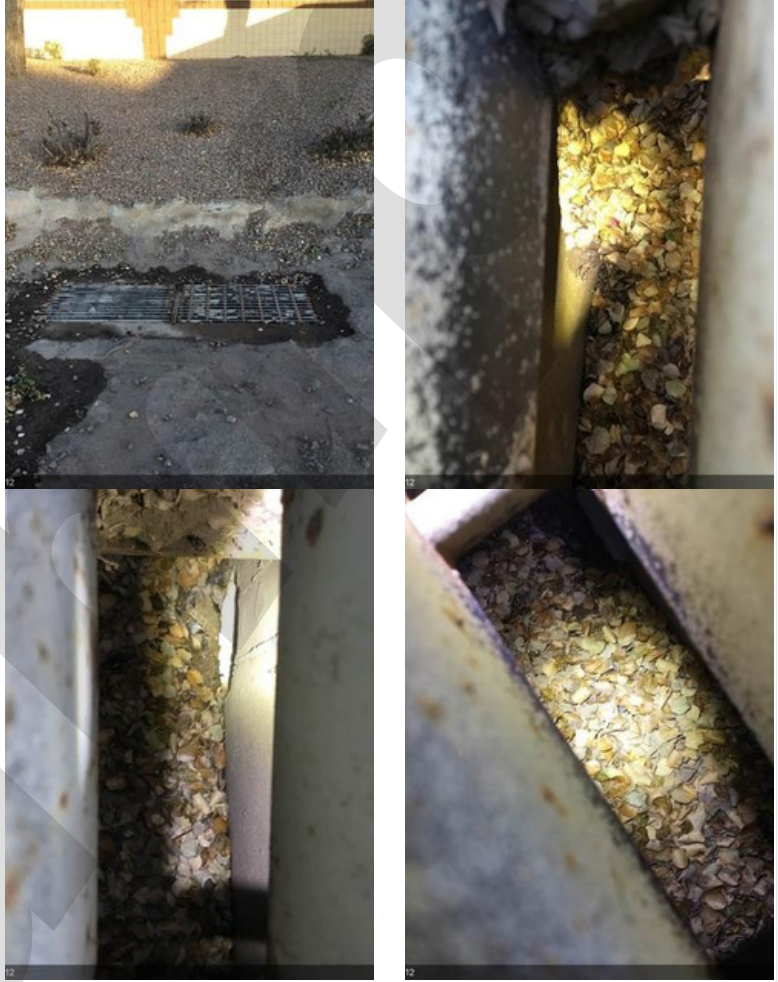
Structure Number	12
Structure Type	Catch Basin
Structure Size	2 - 30"x40"
Depth to Debris	2'11"
Maintenance Needed	Hydrovac cleaning is needed.

Maintenance Notes	Significant amount of landscape debris buildup
Repairs Needed	None
Photos

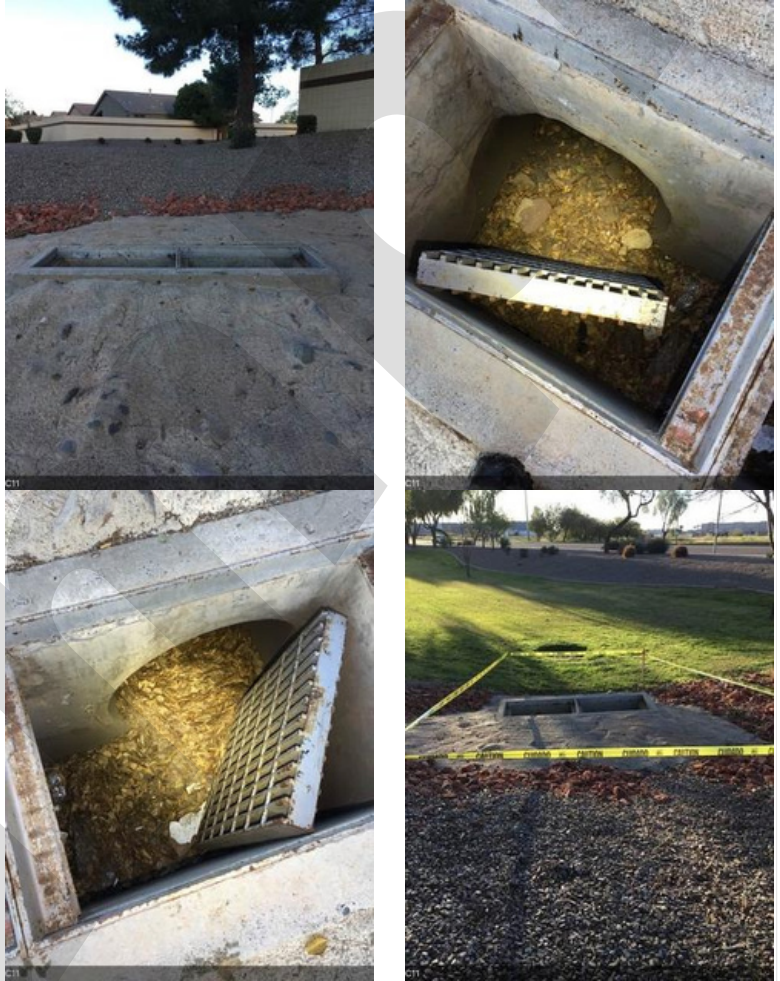
Structure Number	11
Structure Type	Bubbler Basin (catch basin)
Structure Size	2 - 30"x40"
Depth to Debris	3'
Maintenance Needed	Hydrovac cleaning is needed.
Maintenance Notes	Significant amount of landscape debris buildup

Repairs Needed	Need to reseal grates. Present but inside of structure.
Photos

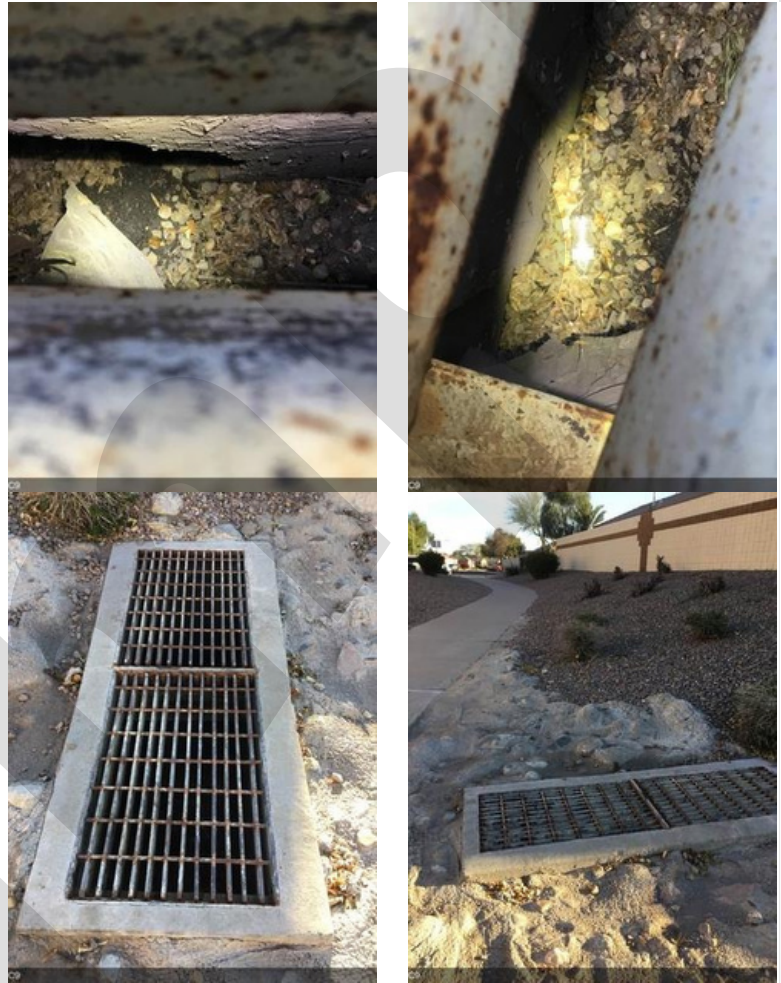
Structure Number	9
Structure Type	Bubbler Basin (catch basin)
Structure Size	2 - 30"x40"
Depth to Debris	4'4"
Maintenance Needed	Hydrovac cleaning is needed.
Maintenance Notes	Moderate amount of landscape debris buildup and dirt
Repairs Needed	None

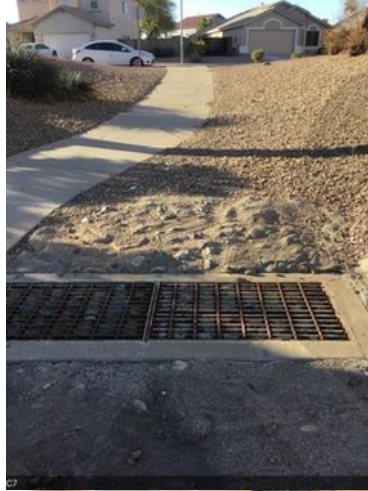
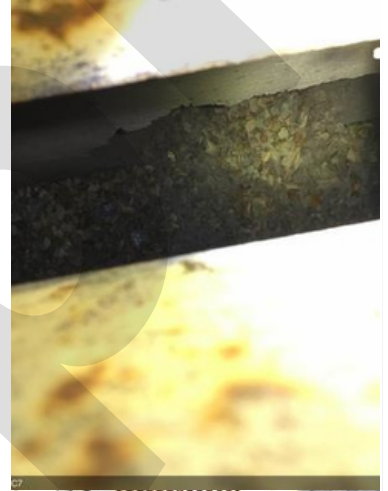
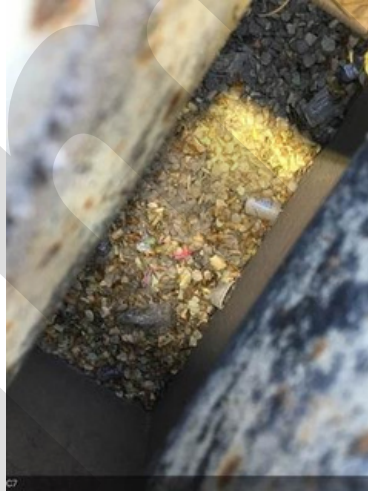
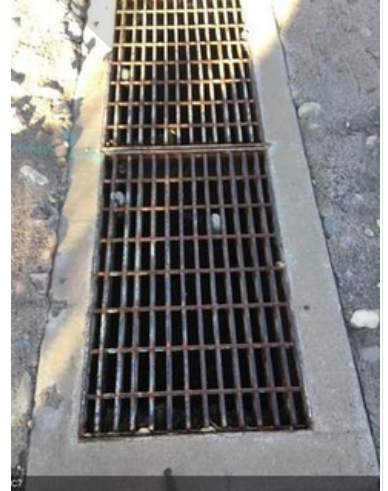
Structure Number	7
Structure Type	Catch Basin
Structure Size	2 - 30"x40"
Depth to Debris	5'1"
Maintenance Needed	Hydrovac cleaning is needed.
Maintenance Notes	Moderate amount of landscape debris buildup
Repairs Needed	None

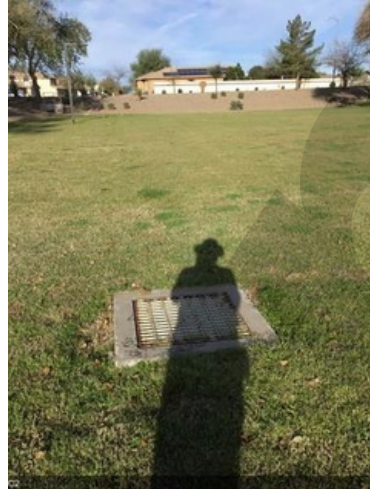
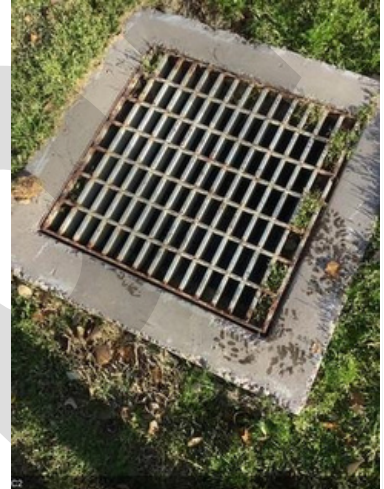
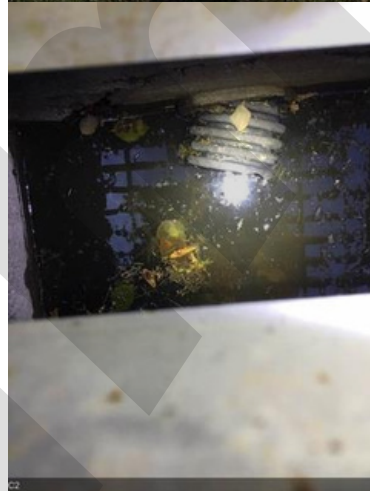
Moderate amount of dirty standing water with slight sheen.

Hydrovac cleaning is needed.

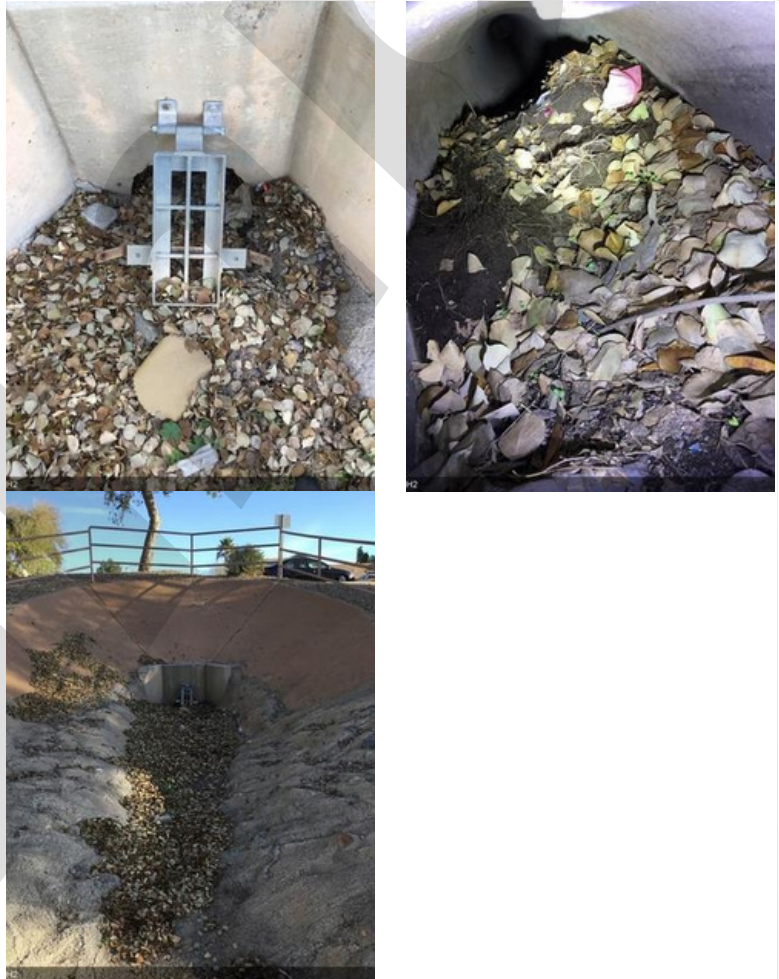
Structure Number	2
Structure Type	Headwall
Structure Size	18"
Percentage Obstruction at Opening	40% obstructed.
Percentage Obstruction in Pipe	Pipe is clear

Maintenance Needed	Hydrovac cleaning is needed.
Maintenance Notes	Significant amount of landscape debris buildup and dirt
Apron	Good.
Trash Rack Condition	Refasten.
Photos of Headwall

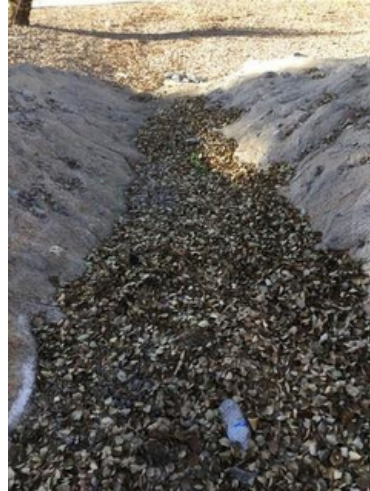
<p>The photos show a concrete headwall with a trash rack. The top-left photo shows the trash rack partially obscured by a large pile of leaves and debris. The top-right photo is a close-up of the debris. The bottom photo shows the riprap area below the headwall, which is also covered in a thick layer of leaves and dirt.</p>
Riprap	Riprap needs hydrovac cleaning.

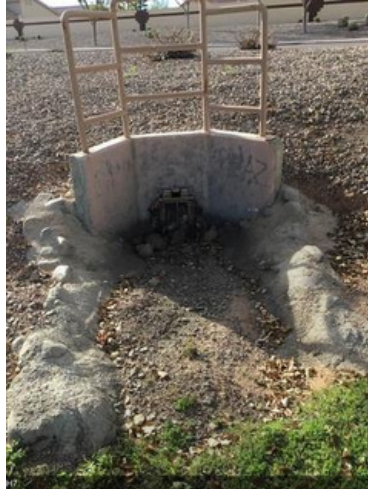
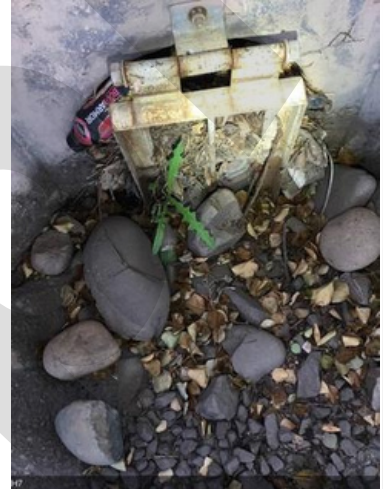
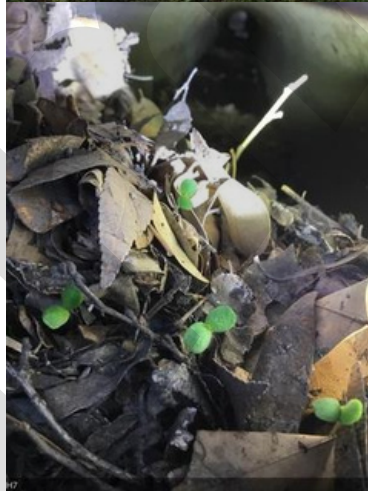
Structure Number	7
Structure Type	Headwall
Structure Size	18"
Percentage Obstruction at Opening	90% obstructed.
Maintenance Needed	Hydrovac cleaning is needed.
Maintenance Notes	Significant amount of landscape debris buildup at outlet and moderate buildup inside pipe
Apron	Needs Cleaning
Trash Rack Condition	Fair. Continue to monitor.

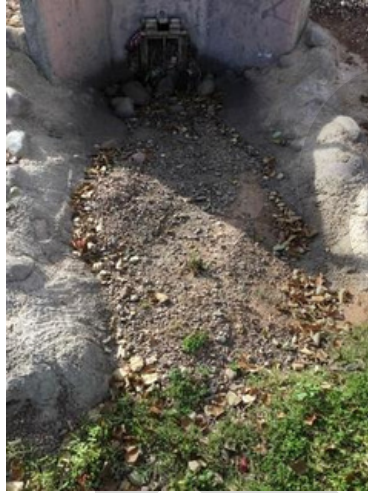
Riprap needs hydrovac cleaning.
